# Slip slidin' away: slope failure at East Knob borrow pit, near Anaconda, Montana

**Katie Lethenstrom**

Department of Geology, Whitman College, Walla Walla, WA 99362

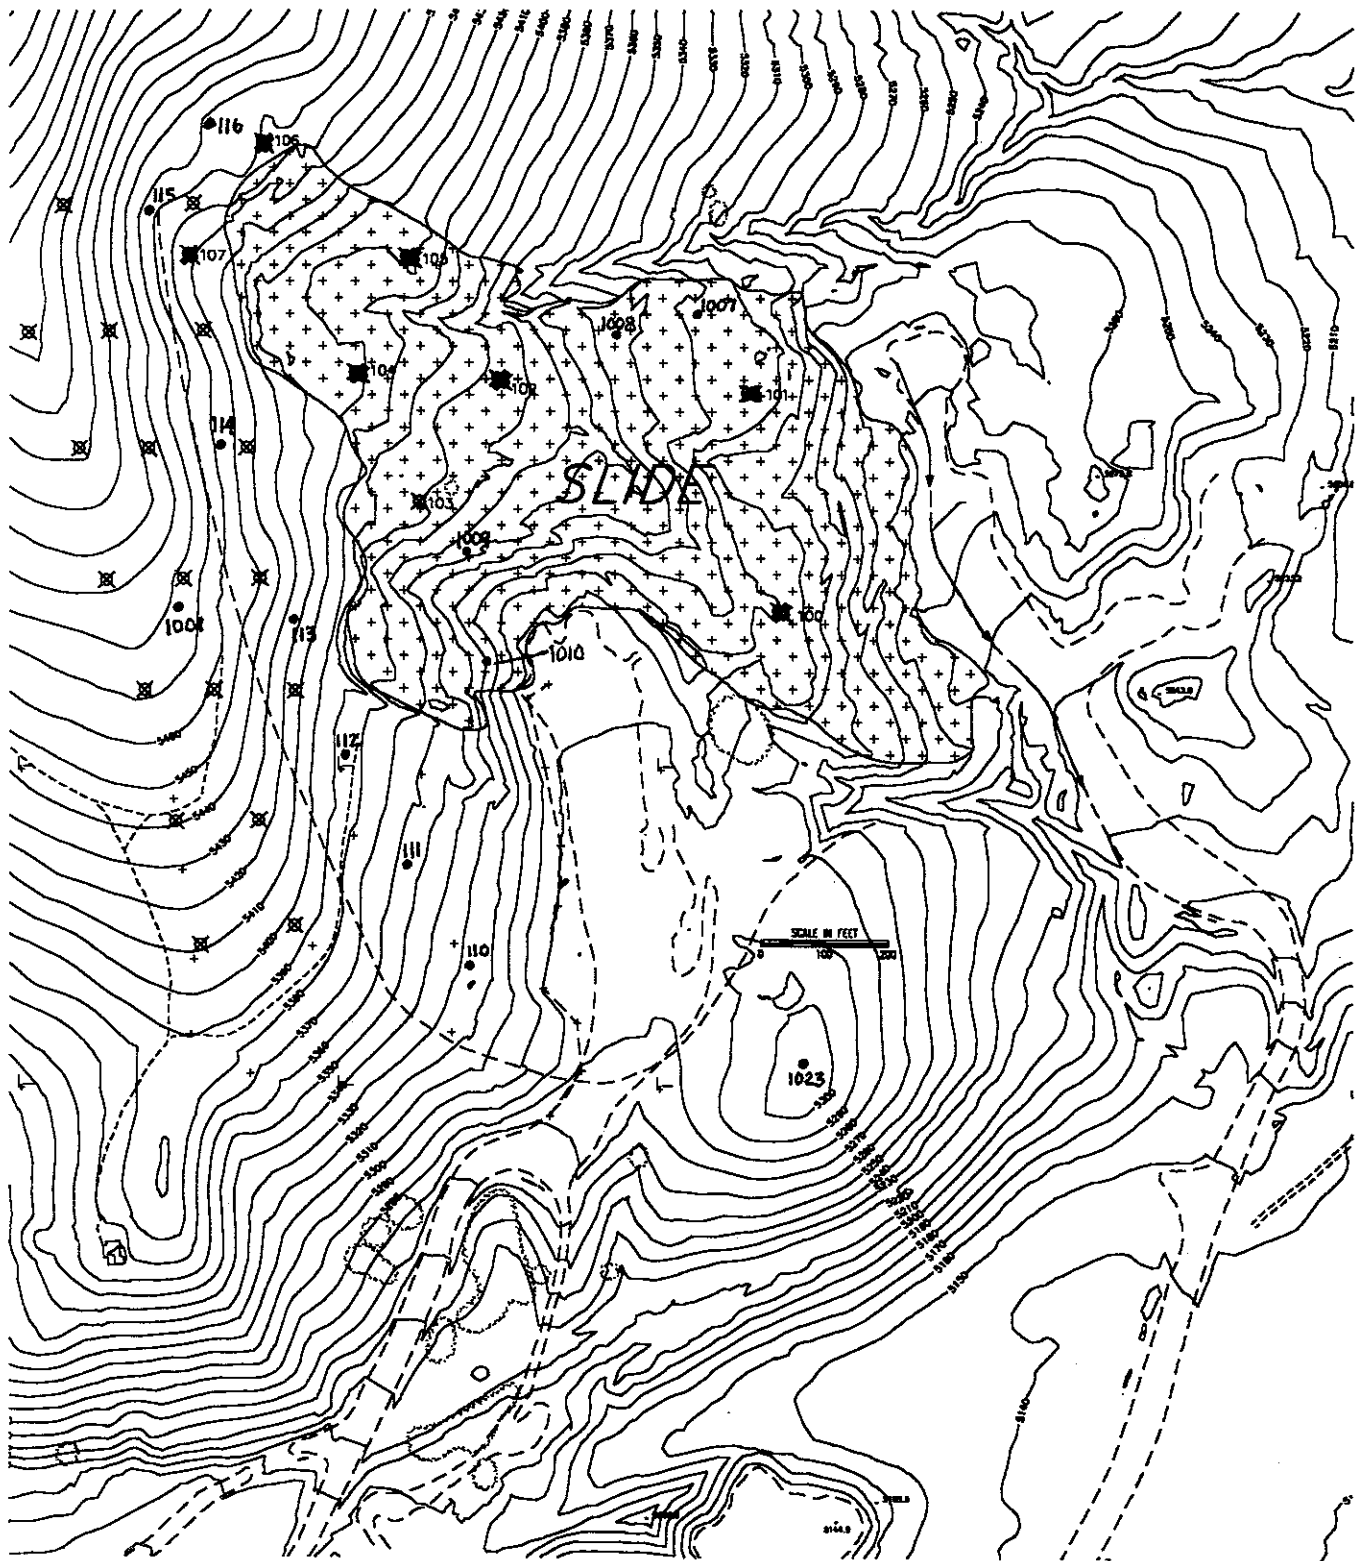
Figure 1: Map showing outline of slump-earthflow and location of survey stations. (Source: Atalantic Richfield Company, 1996)

The landslide occurs in the Old Works Diamicton on the east facing slope of East Knob (Figure 1). Based on the mass wasting classification by Varnes (1958), the area of failure is a slump-earthflow combination. The upper portion of the slump failed in coherent blocks, which rotated in places, and retained the lag pavement cover. As the upper portion failed, the lower portion most likely turned into an earthflow, as indicated by lack of coherence in the material and severe disturbance of the lag pavement. The exact toe is indistinguishable due to the removal and reworking of material. The area of the slide is approximately 57,000 m<sup>2</sup> (0.057 km<sup>2</sup>). The volume of the slide is unknown, as no known detachment surface was observed. The main head scarp averages 5 m in height.

**Dynamics of the failure.** Surveys taken from July 30 through August 12, 1996 show the slump-earthflow moved an average of 0.3 m. Stations 100, 102, 104-107, and 1010 showed movement (Figure 1), ranging from 0.2 to 0.4 m. This movement correlates well with the DJA survey data taken near the same time. Stations located on the flow and slump show no significant differences in amounts of movement. Station 103, however, shows no evidence of movement. Since 103 lies near the high pit, its lack of movement is most likely explained by the termination of excavation in the high pit because of safety reasons. Station 1010 does lie near the high pit, on a small tributary flow lobe. Movement of 0.4 m was recorded, most likely due to saturation. As expected, survey points located outside of the failed area show no evidence of activity, supporting field evidence that the slope outside the landslide is currently stable. The survey data is also supported by small changes in bearings from the nails sets put near cracks. In general, the landslide is moving southeast.

**Causes of failure.** Initial failure of the slope was caused primarily by removal of the toe, which decreased lateral support, and blockage of a natural drainage, which increased saturation of the hill. During removal of material, a natural drainage on the southeast end of the slide area was blocked with waste material. In the lower pit, flow material at the toe of the slide built up, along with the waste material from borrowing. These two altered runoff patterns, coupled with the already perched water table and clay content, resulted in saturation of the slope. Once enough lateral support was removed, failure occurred. Both causes continue to have an effect on movement, as supported by survey, precipitation, and excavation information from July and August.

More importantly, ARCO excavated a dewatering ditch in the lower pit for the purpose of draining water from the failed slope (Figure 1). The ditch, dug in June 1996, starts at the approximate toe of the slide, near the end of the lower pit. The ditch seems to drain the slope fairly well, as it contained standing water and was well saturated during dry months. Survey data from DJA shows that after the first of July, rates of motion decreased. In the period before the ditch was excavated (78 days), 86 mm of rain fell, while after the excavation (85 days), 73 mm of rain fell. So, it can be said that the decrease in rates of motion was from less precipitation and/or draining of the saturated slope. Recently the dewatering ditch had to be cleaned, however, as material began flowing into it (M.P., ARCO, oral communication, January 15, 1997). In conclusion, these efforts have helped, but they have not resulted in complete stabilization of the landslide.
