GEOMORPHOLOGY, GEOCHEMISTRY AND SOIL EROSION ALONG AN AGRICULTURAL STREAM

INTRODUCTION

In this project, a half-kilometer reach of a small tributary of Prairie Creek was studied to determine how a wooded riparian buffer may be affecting water quality and soil erosion in an agricultural area. Our data support recommendations for future management of the study site, which is currently being

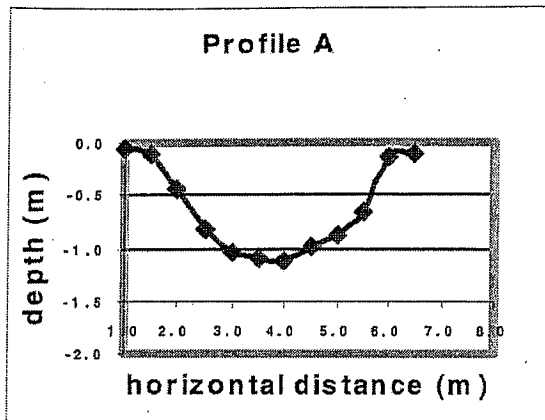
Cross-sections reveal substantial differences in channel width and depth along the length of the reach (Fig. 2). Profile C is in one of the few grassy areas along the buffer. The profile is narrow, 3.5 m, and shallow, with relief of .2 m. Profile B, located in a denser, woodier area 25 m North, is wider than C (5.5 m), but maintains a similar depth. In contrast, cross-sections directly below man-made structures are noticeably wider and deeper than their natural counterparts. Profile A is located 475 m downstream from B and immediately downstream from a 3-foot diameter concrete pipe exposed in the channel. Here, the channel is 6 m wide, with nearly 1 m relief. Similarly, at Profile D, which is situated below a culvert crossing County Road 29, the stream has a width of 9.5 m and 1.5 m of depth.

Channel geomorphology appears to be directly related to the volume of water passing through the area. Cross-section D is both the widest and the deepest section of the stream. During storm flows, the large culvert upstream feeds a high volume of water into the stream in a short time. In contrast, cross-sections B and C are located in areas where there was little or no water during the study period, and the lack of water appears to have resulted in flat, shallow channel.
