WATER RESOURCES ON VINALHAVEN, MAINE

ANDREW P. DE WET Franklin & Marshall College

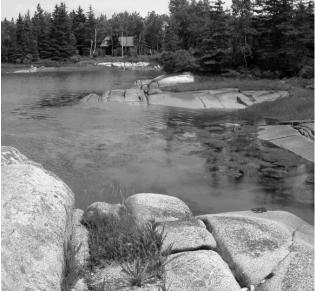
Figure 2: Coarse-grained biotite-hornblende granite with widely spaced vertical open fractures, Mill River, Vinalhaven, ME.

Vinalhaven, located in Penobscot Bay, Maine, includes 46 islands over 3 acres and covers an area of ~15,000 acres (Fig. 1). Topographically the island is relatively low lying with a maximum elevation of 200 feet. The bedrock geology is mostly granite locally covered with a thin layer of soil (Gates, 2001) (Fig. 2). Water resources on Vinalhaven have been an issue of considerable concern for many decades (Gerber 1989). Vinalhaven groundwater is an 'island aquifer' – a lens of fresh water bounded on all sides by the ocean. The main sources of water for the 1300 year-round residents and ~4000 summer residents are private wells and the Vinalhaven Water District that obtains its water from Round Pond. Water supply is particularly problematic during the drier summer months when the demand is highest due to the increased
